Risk Services Report

CONDOMINIUM CORPORATION 1122235 RIVER PARK GLEN

February 25th, 2020

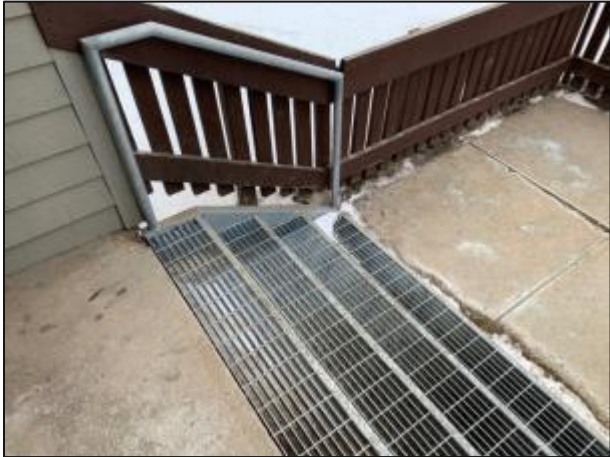
Upgraded & Repaired Stairs

Repairs are conducted when required with evidence of stair replacement noted at the Low Rise Building.

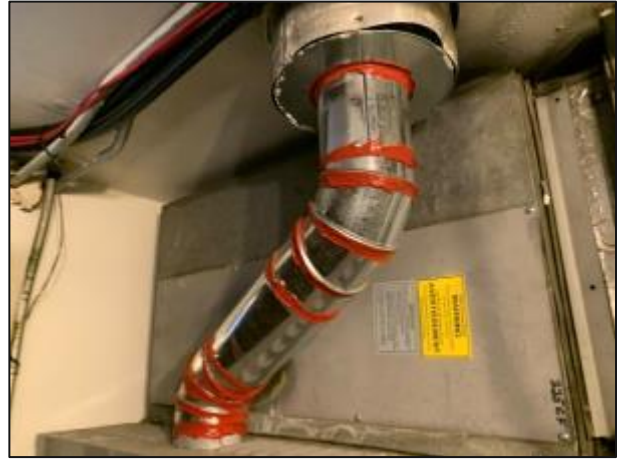
All Connections Sealed
